Connecticut Embayments Study

Department of Environmental Protection
State of Connecticut

Phase I Inventory & Problems Analysis

PHASE I - INVENTORY AND PROBLEMS ANALYSIS

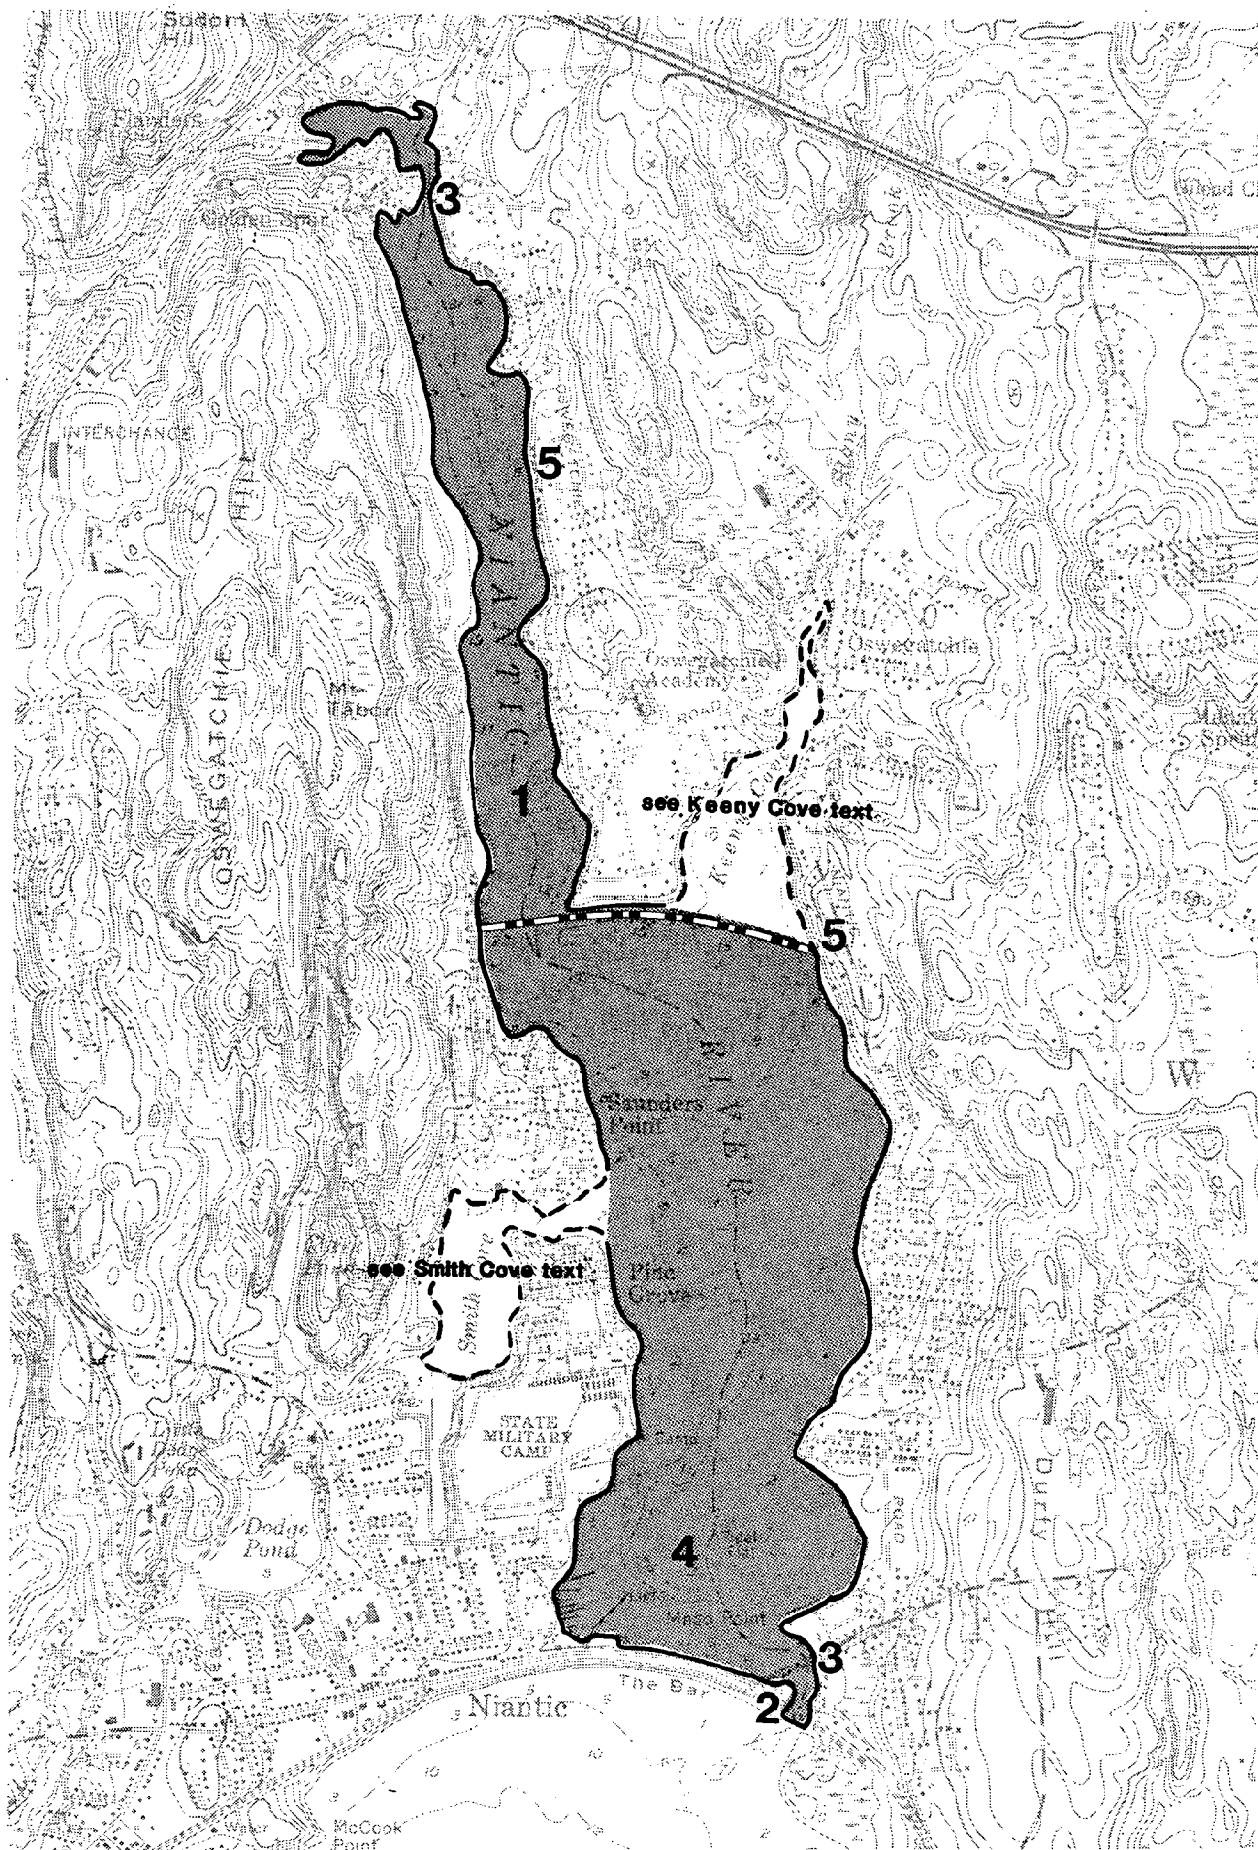
1. Upper half of bay is closed to shellfishing
2. Railroad bridge constricts flow
3. Highway bridge (Rt. 1) constricts flow
4. Shellfish loss associated with low tides in winter
5. Wastewater problem area
